# PASER **Brick & Block** Manual

## *Pavement Surface Evaluation and Rating*

Brick or block materials have been used for many years for street surfacing. This publication provides a system to evaluate and rate brick and block streets. The rating system is consistent with other PASER rating manuals and the evaluations can be used in a pavement management system or for the Wisconsin Information System for Local Roads (WISLR).

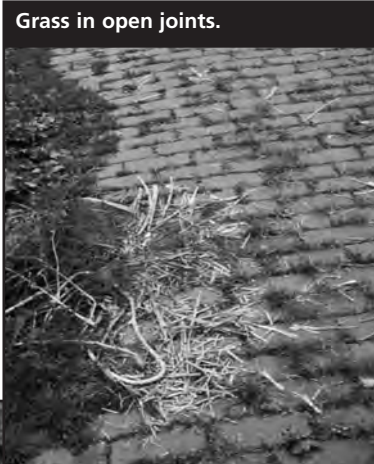
Open joints may fill with dirt and be covered with vegetation in lower traffic areas. ▶

Grass in open joints.

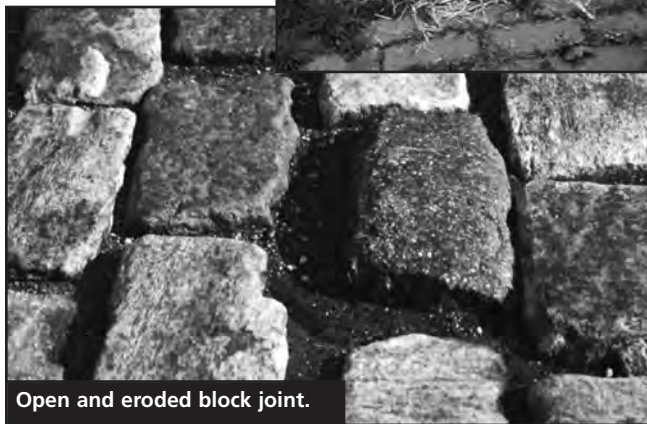
Joints may become eroded, allowing water to collect between the bricks or blocks. ▼

Open and eroded block joint.

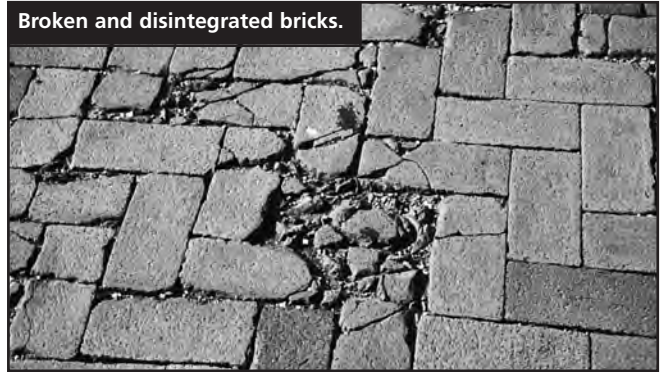
A brick or block may be broken. Often the breaks are either on a corner or edge and the pieces usually become dislodged and are removed from the pavement surface. Broken or settled bricks or blocks may also occur adjacent to manholes, valve boxes and inlets. ▼

Broken and disintegrated bricks.

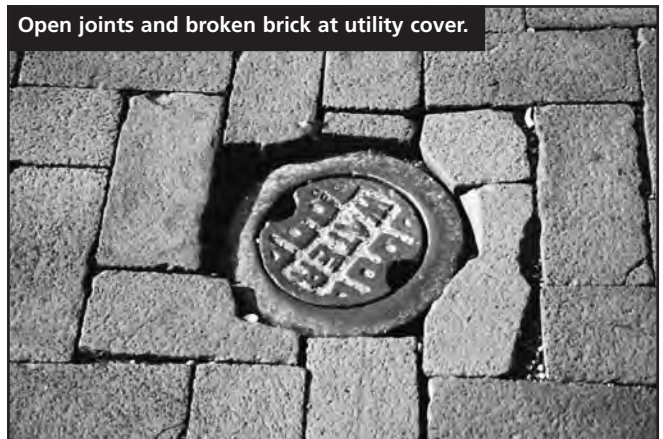
Open joints and broken brick at utility cover.

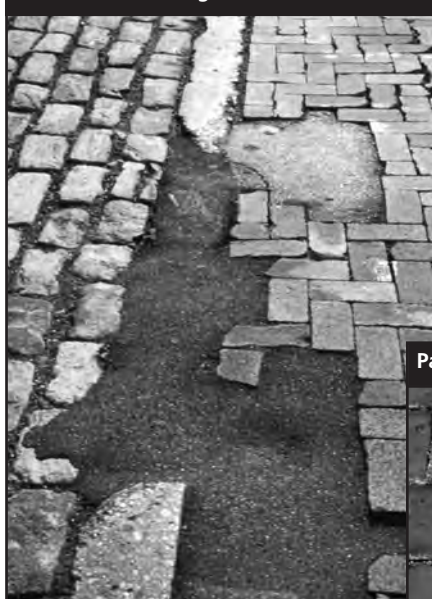
Patches for missing bricks and blocks.

◀ Bricks or blocks may be missing.

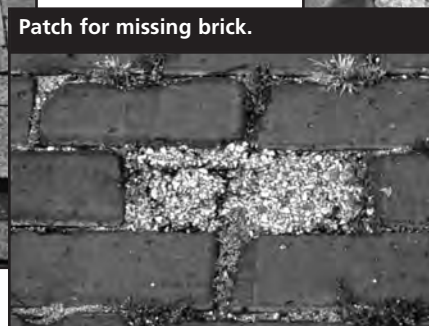
Occasionally, the gaps are patched with either asphalt or concrete. ▼

Patch for missing brick.

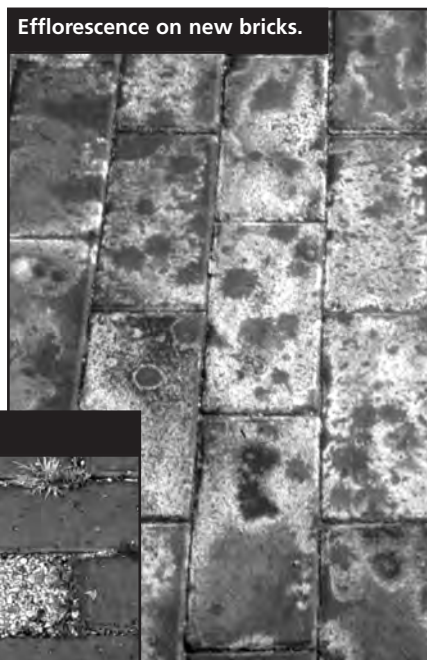
Efflorescence on new bricks.

◀ New bricks may develop a white coating called efflorescence. This is minerals surfacing from within the brick material and can be cleaned off. Efflorescence is a cosmetic problem but it may cause some complaints.

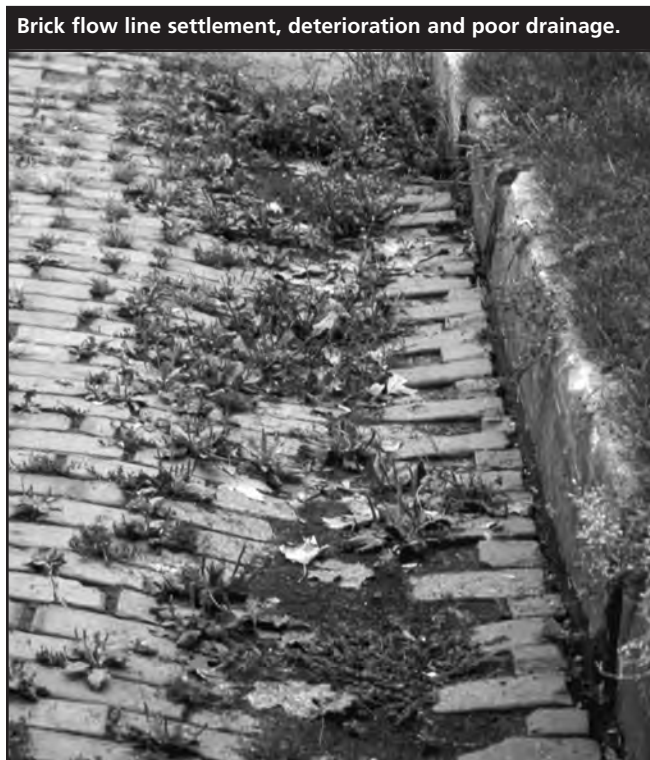
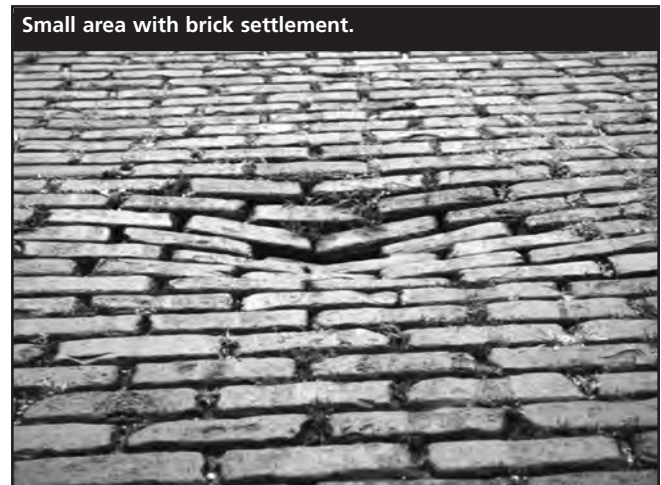
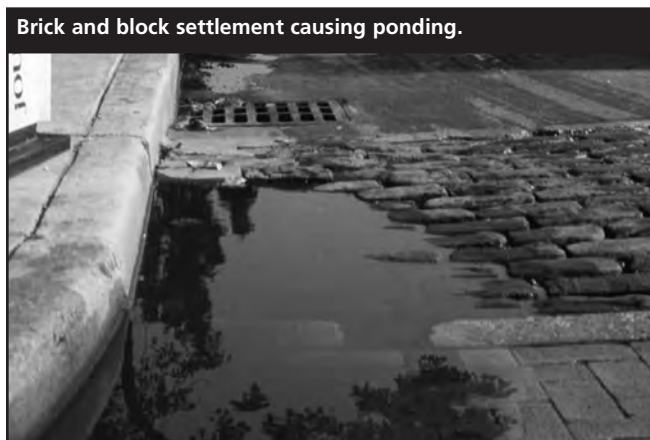
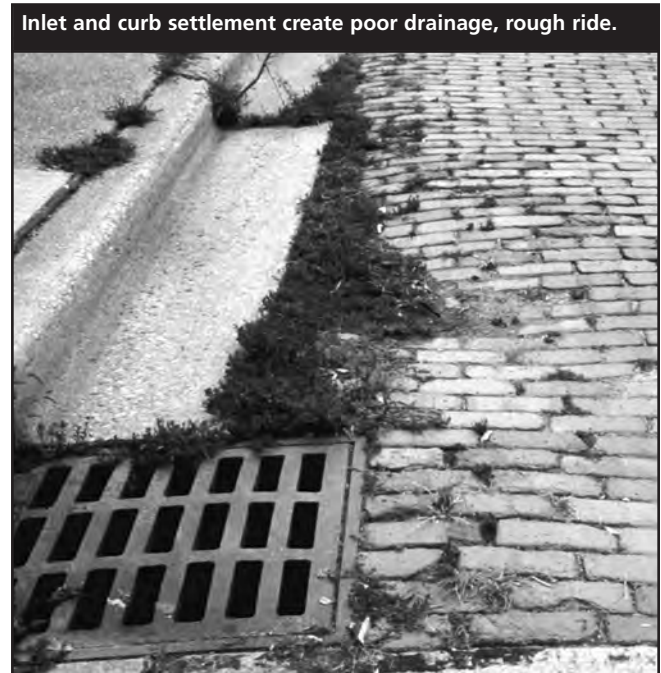
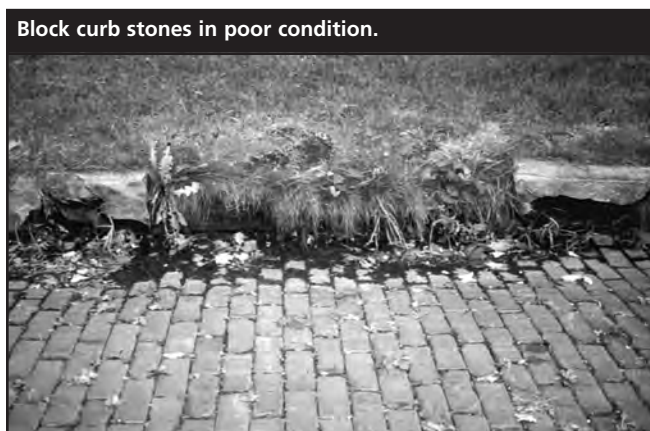
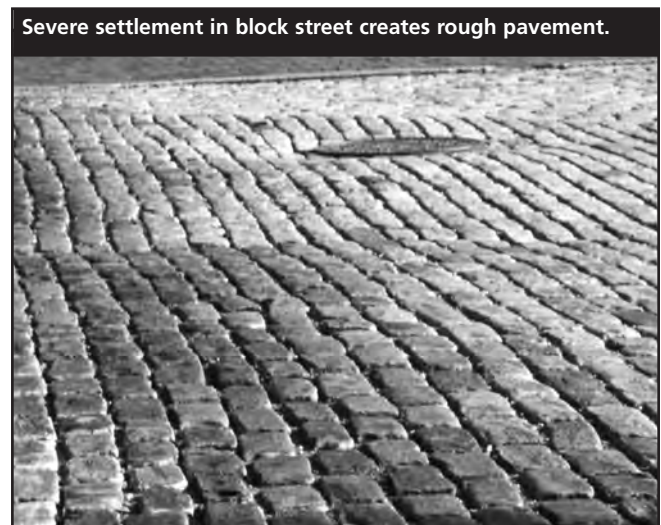
##### SETTLEMENT

Brick or block streets may have sunken or settled areas. These may be isolated areas or they may have adjacent settlements creating a rippled effect.

The flow line adjacent to the curb may settle. This creates ponding and often collects debris.

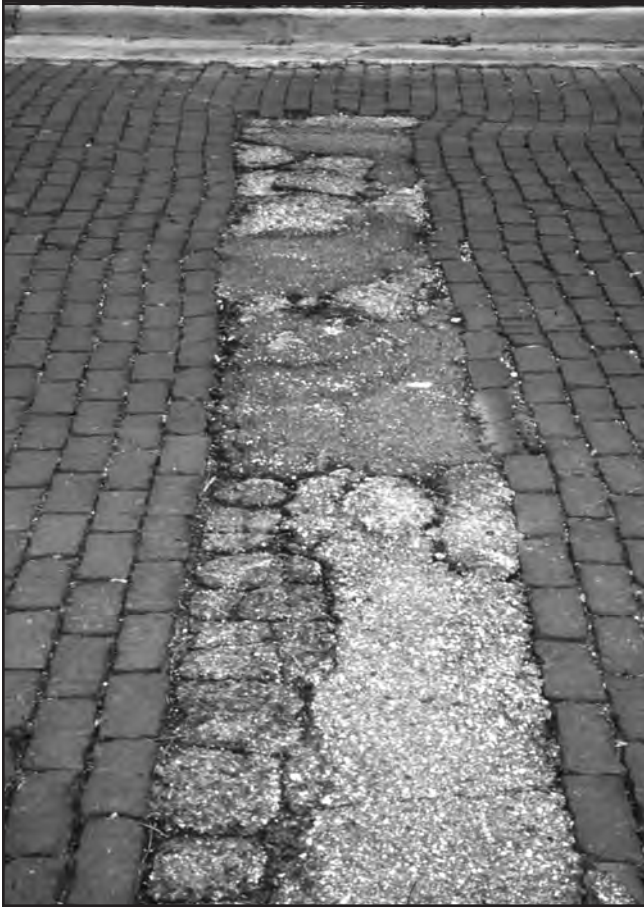
Utility repairs may be patched with asphalt or concrete or restored by relaying brick and block.

Utility repair patched with asphalt.

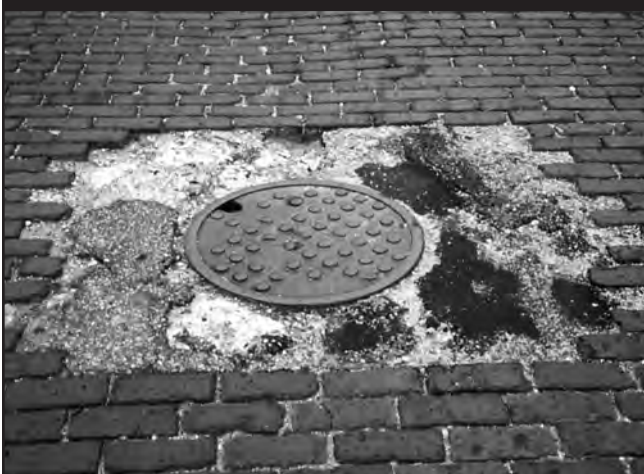
Manhole repairs leaving surface in very poor condition.

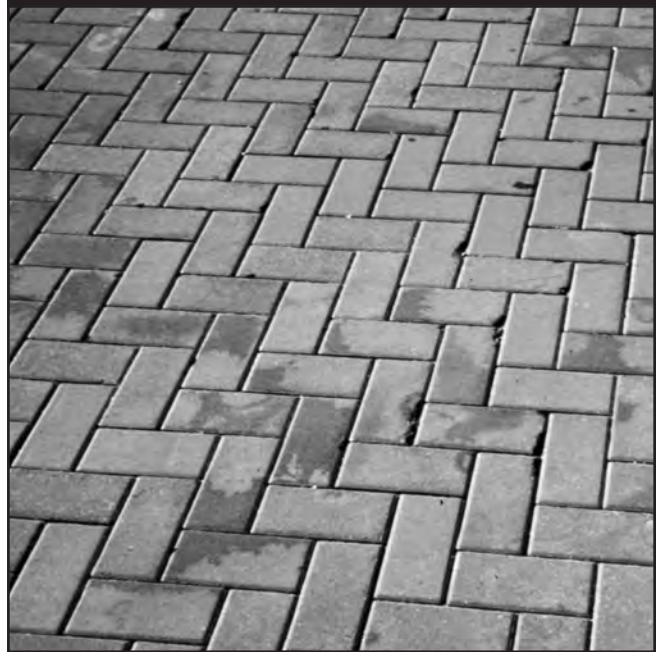
The ride quality of brick and block streets varies significantly. Pavements with very narrow and tight joints and a level surface may have a very smooth ride and minor traffic noise. Streets with some settlement and open joints can produce a very rough ride and significant traffic noise.

Smooth riding new brick street.

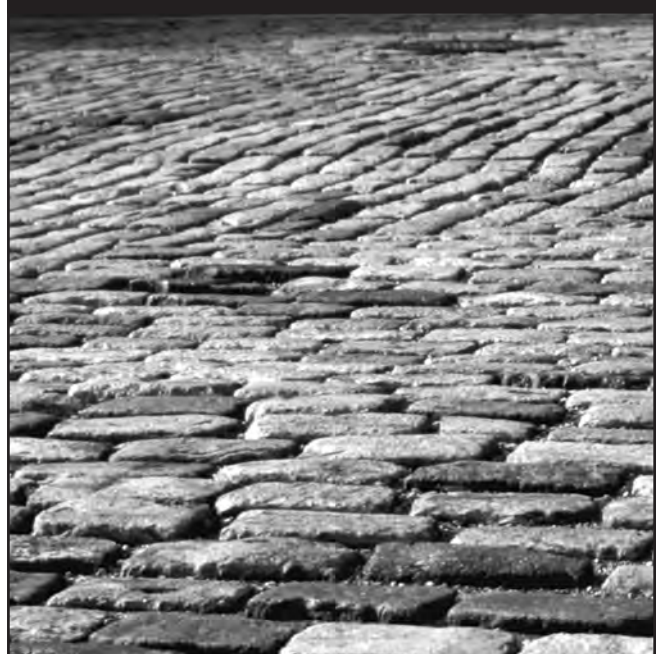
Rough and noisy block street.

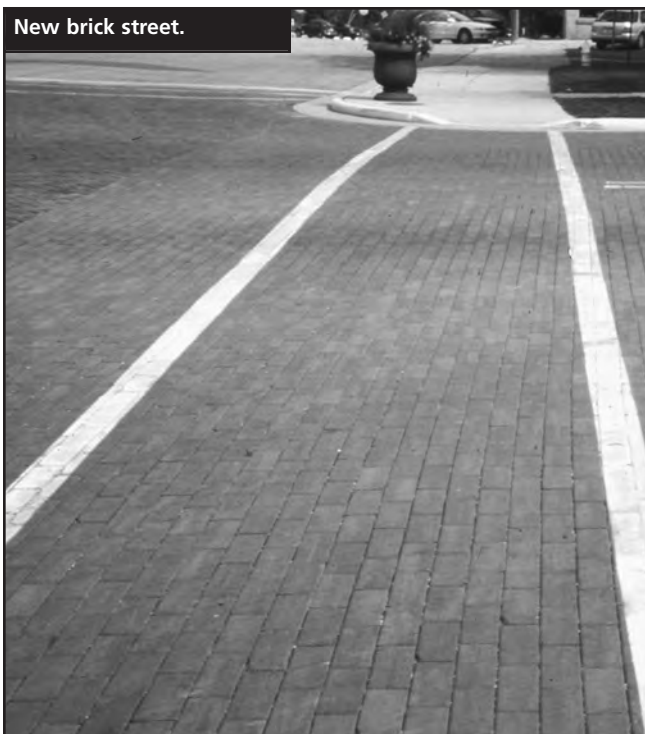
## ✓ 4 – VERY GOOD

New condition. No defects.

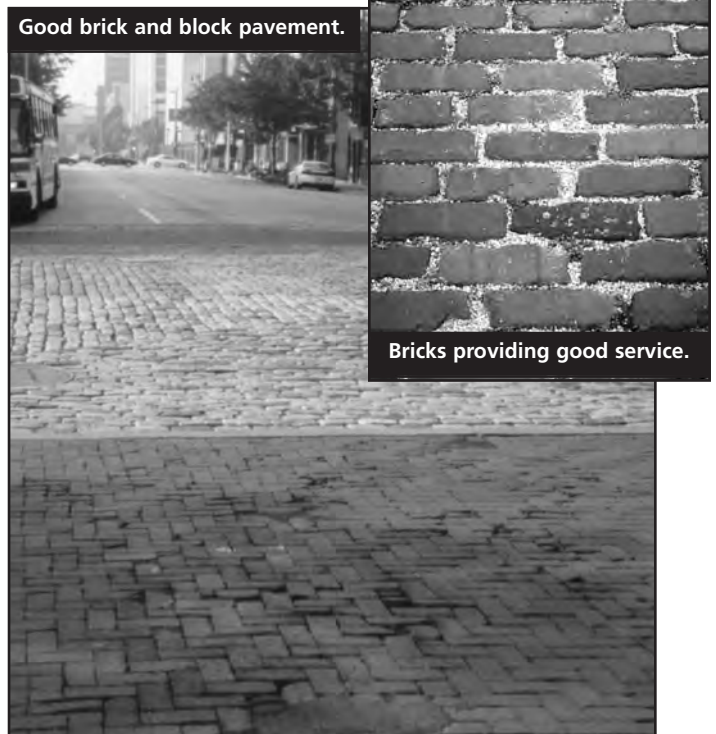
## ✓ 3 – GOOD

Few defects. Good ride.

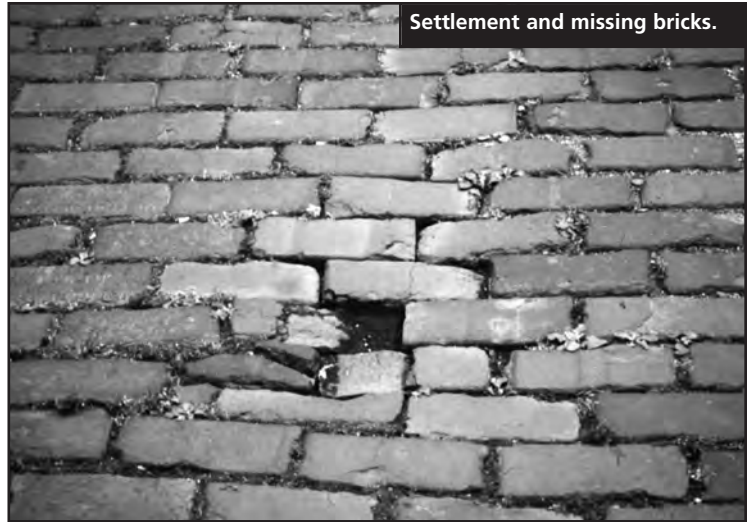
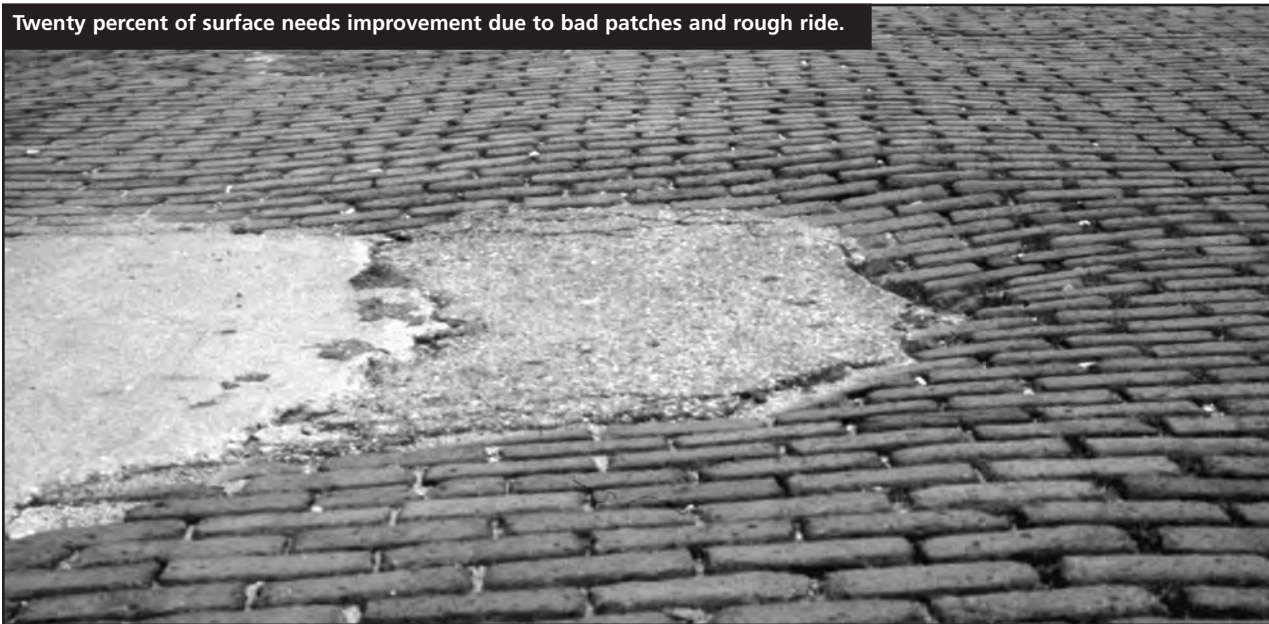
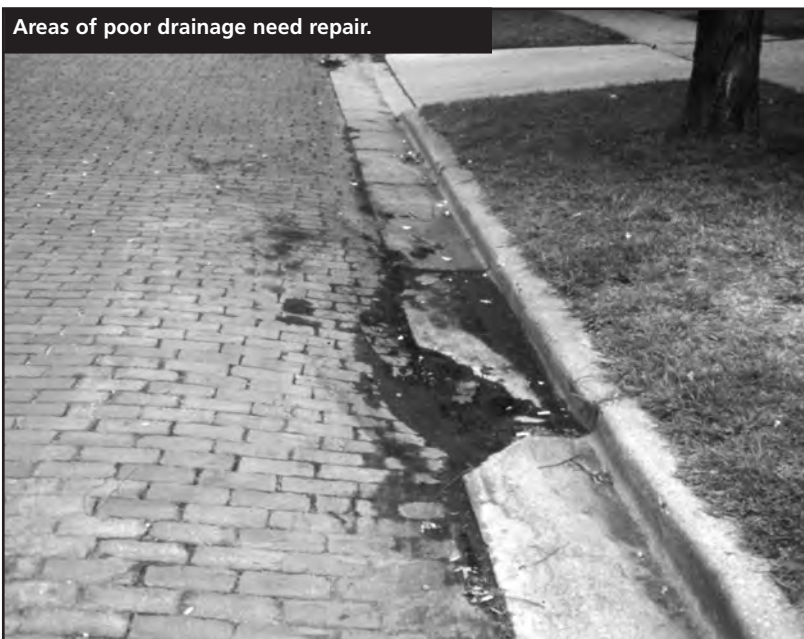
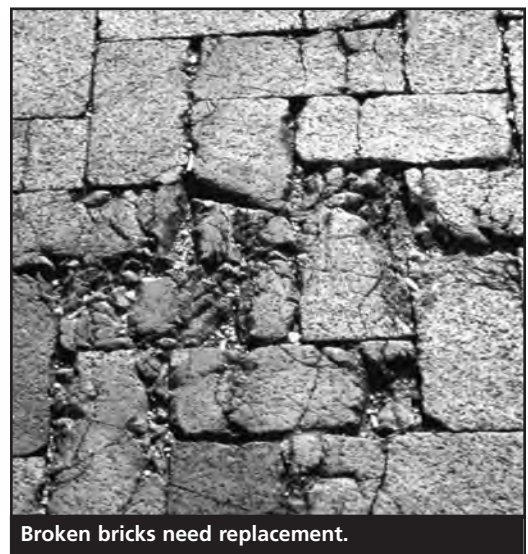
**✓ 2 – FAIR**

One or more types of defects extending over 5 to 25% of the surface area.

Overall ride may be uneven and rough.

Sunken or settled areas.

Broken bricks or blocks.

Areas of poor drainage.

Open joints.

Spot repairs are recommended.

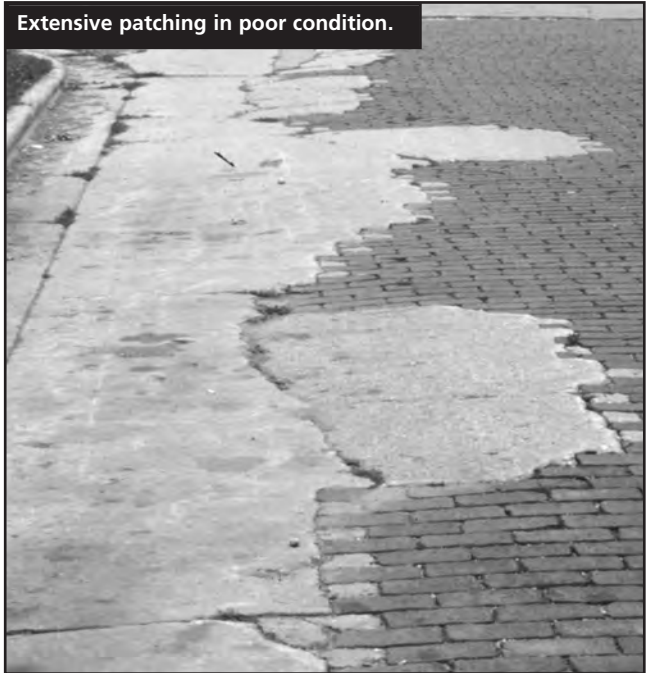
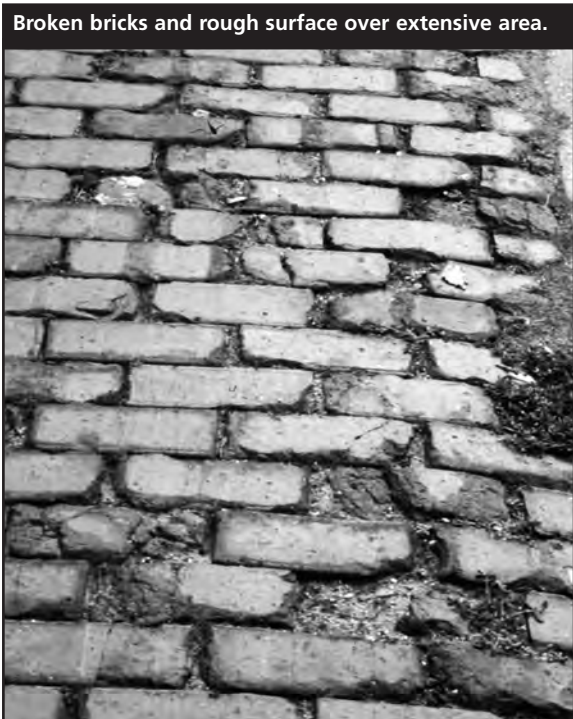
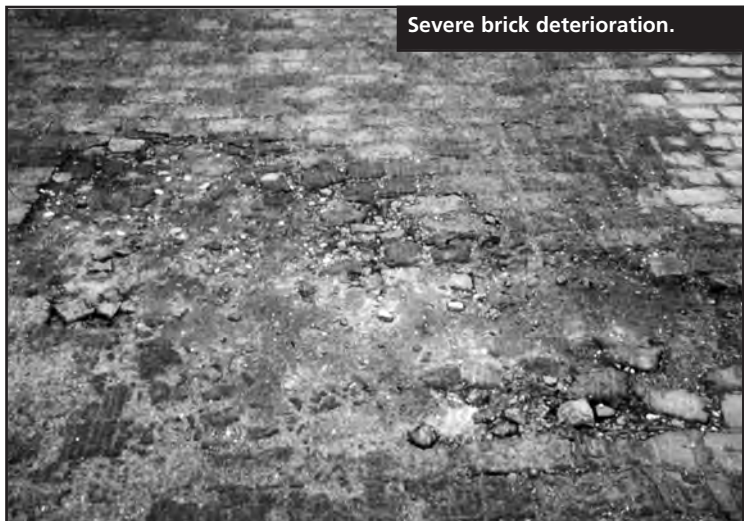
**✓ 1 – POOR**

Defects cover more than 25% of the surface area.

Very rough ride.

Numerous patches in fair to poor condition.

Poor drainage.

Requires extensive repair or reconstruction.
